Revisiting the wall paintings of St Demetrios church in Klimatia village (Epirus, NW Greece)

Georgios P. Mastrotheodoros^{(1,2)*}, Eleni Filippaki⁽²⁾, Yorgos Facorellis⁽¹⁾, Konstantinos G. Beltsios⁽³⁾, Varvara Papadopoulou⁽⁴⁾

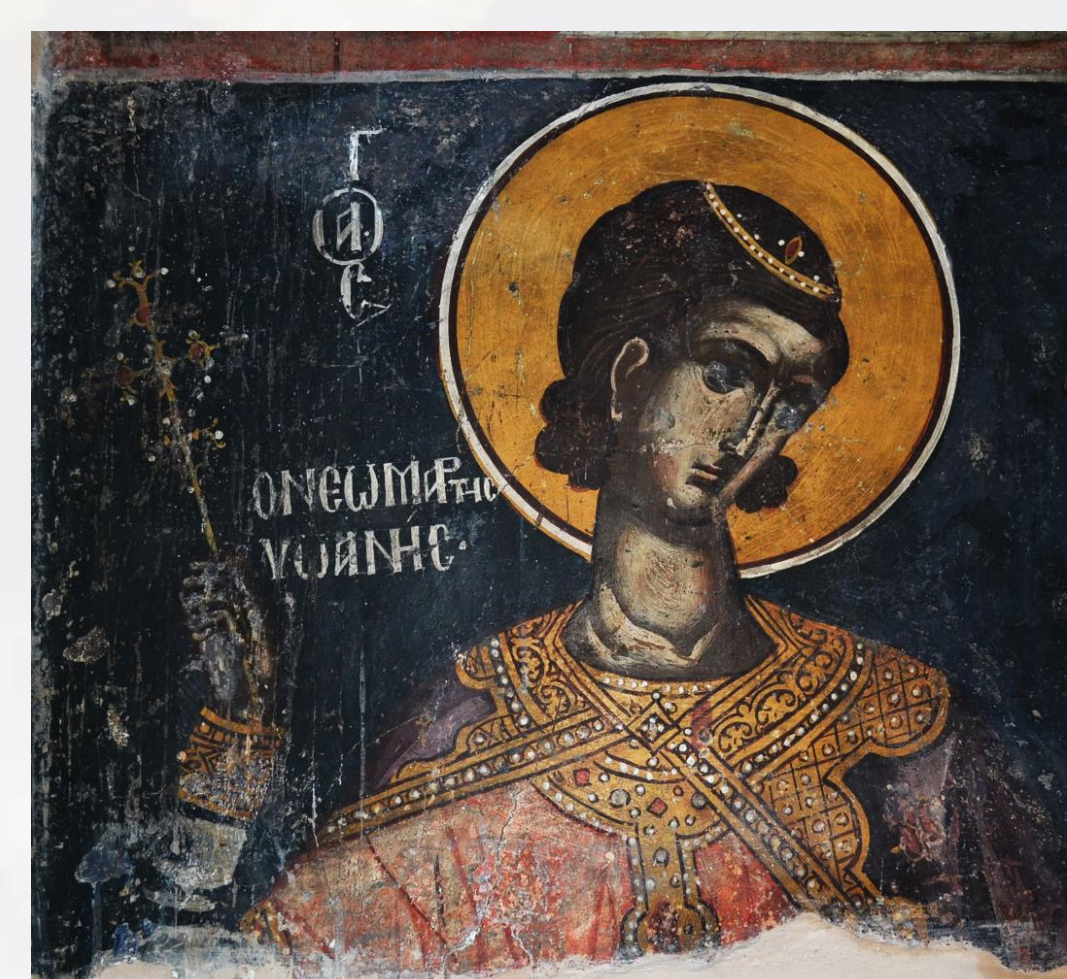
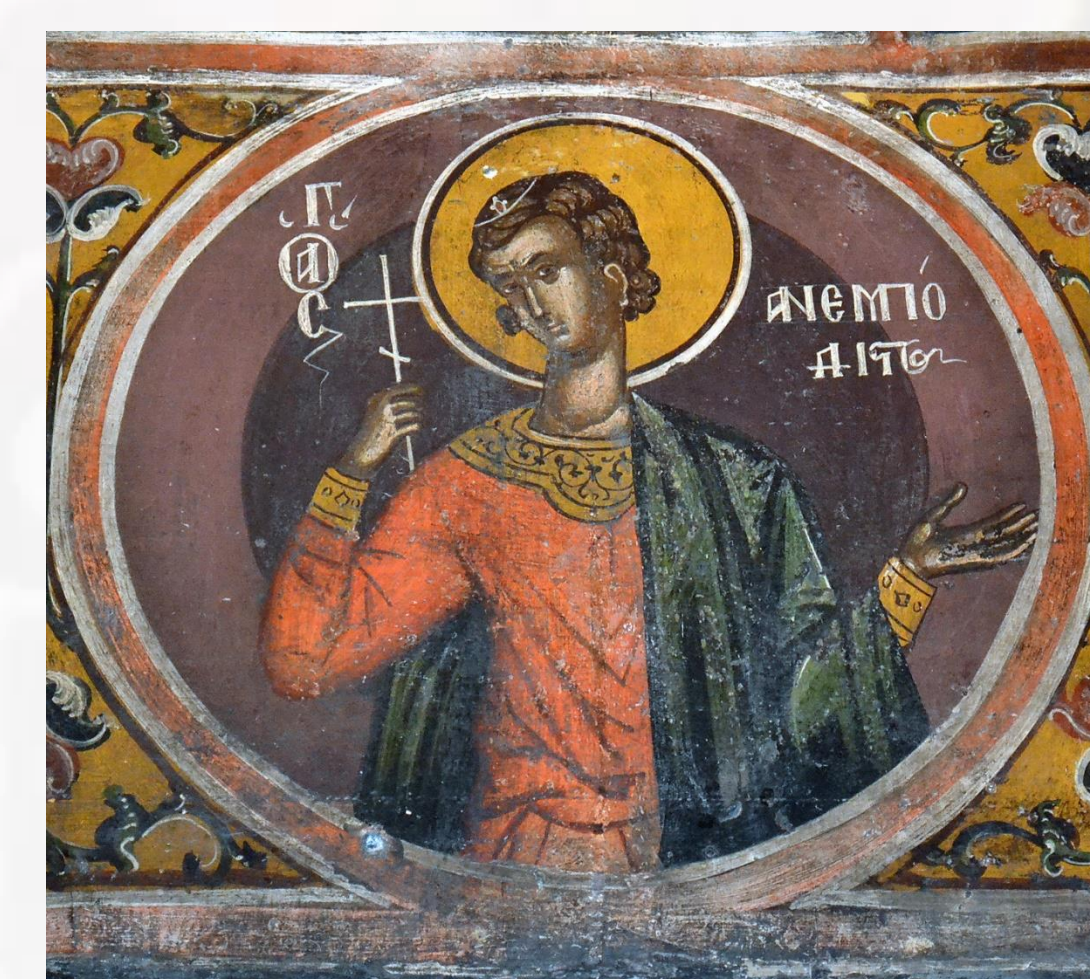
Figure 2 St Demetrios church murals, details.

Several micro samples were collected from areas of pre-existing paint losses and micro-cracks (Fig. 2) and were subsequently thoroughly investigated through stereoscopy, optical (OM) and scanning electron microscopy (SEM-EDX), and FTIR. Analytical data were interpreted through comparison with data obtained by earlier pertinent studies [4-6].

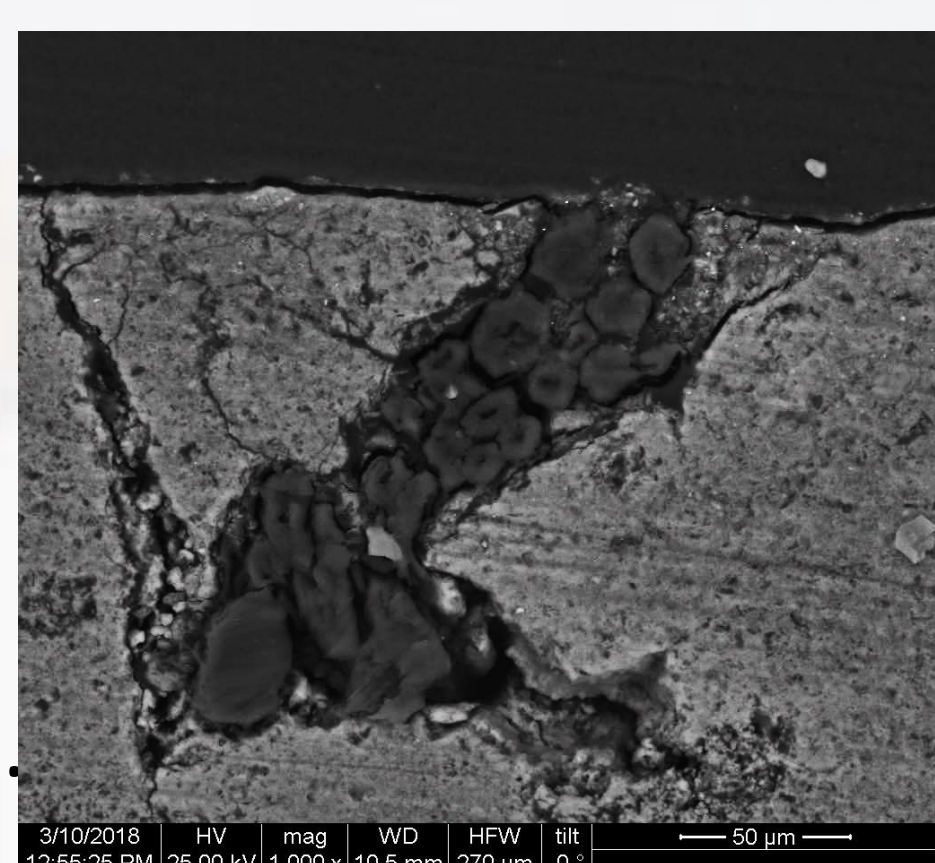
Figure 3 From left to right: (a) cross-section of flax fibers, surface plaster (SEM, 1000×) (b) Green earth grain (center) surrounded by a calcareous matrix (SEM, 5000×). (c) Charcoal grains of plant origin (black grains, SEM, 2400×). (d) Smalt (bright grain, center) next to charcoal grains (black) (SEM, 4000×). (e) Extensive diffusion of yellow ochre in surface plaster (OM, 200×).

The recent analyses added a considerable body of information to that obtained by the first analytical investigation [4]. In detail, probing revealed that the surface plaster (“intonaco”) contains minor quantities of flax and other plant materials (possibly straw) (Fig. 3a). Moreover, it turned out that the palette used by the St Demetrios painter(s) is richer than previously thought: indeed, apart from the pigments red ochre, cinnabar, lime and carbon black (identified in [5]), authors spotted yellow ochre, green earth and smalt (Fig. 3b). It is also worth noting that the recent analyses revealed employment of at least two different (in terms of composition and hue) red ochres, a substance that seems to correspond to St Giovanni white pigment (artificial CaCO_3), as well as that the carbon black is of plant origin (Fig. 3c). Note that this palette is identical to those identified in works that are related to (or signed by) the Kontaris brothers [5, 6], while an idiomorphic technique for rendering the dark-blue backgrounds was also identified. The latter corresponds to the application of a charcoal plus smalt mixture directly onto the wet plaster (Fig. 3d) and is regarded as a Kontaris invention [5], that deviates substantially from the practices employed in other contemporary wall painted monuments [8, 9]. Note also that the application of pigments on wet plaster has been attested in various other (non-background) samples (Fig. 3e) revealing thus that at least part of the painting was conducted in the fresco technique. On the other hand, the in depth SEM-EDX investigation of the micro-samples revealed presence of surface accumulation remnants, that were presumably not removed during the recent conservation intervention (Fig. 4). Moreover, grains of modern pigments (e.g. mars black, Fig. 4) were spotted on areas of original painting indicating thus extensive retouching interventions.

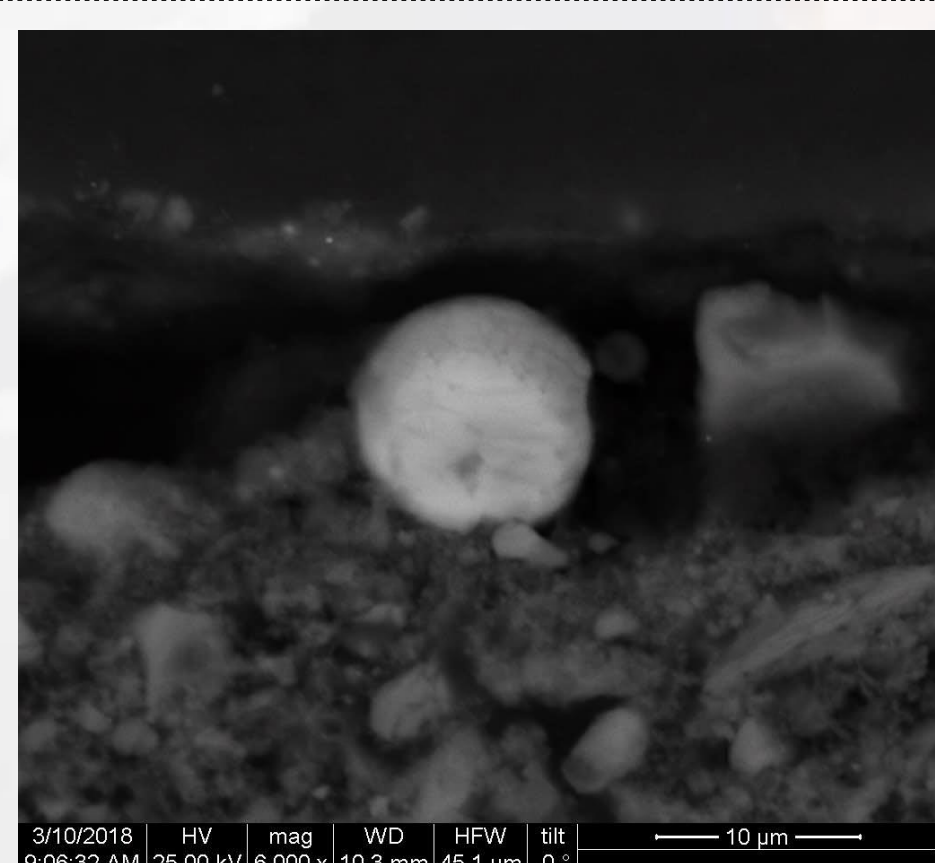
Figure 4 Mars black (bright grain) on top of original painting (SEM, 6000×).
